# Normal Anterior Cruciate Ligament

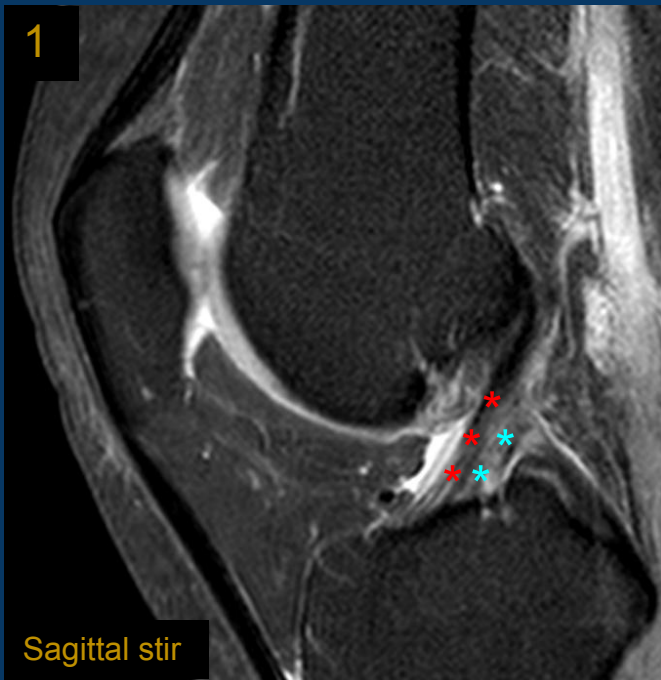
**Figure 1 (stir):** Sagittal image of the anterior cruciate ligament (ACL) reveals two distinct bundles, the anteromedial (red asterisk) and the posterolateral (blue asterisk). These bundles exhibit intermediate to high signal intensity on T2/STIR sequences which should not be mistaken for a lesion, as the fibrillar pattern remains intact.

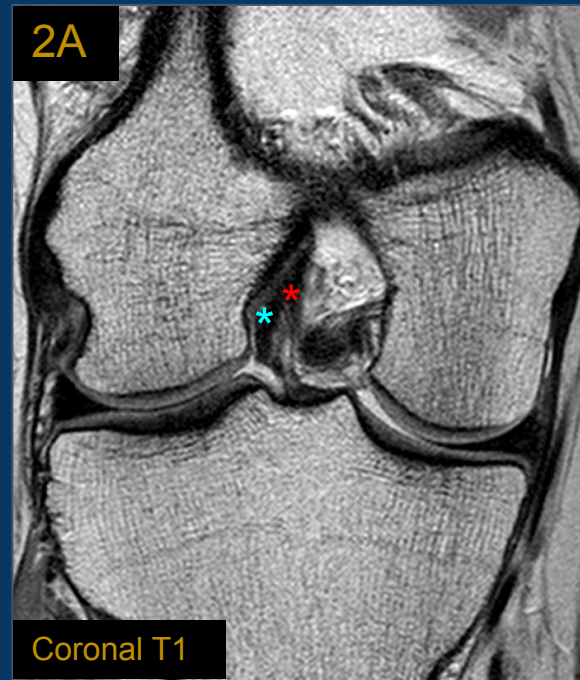
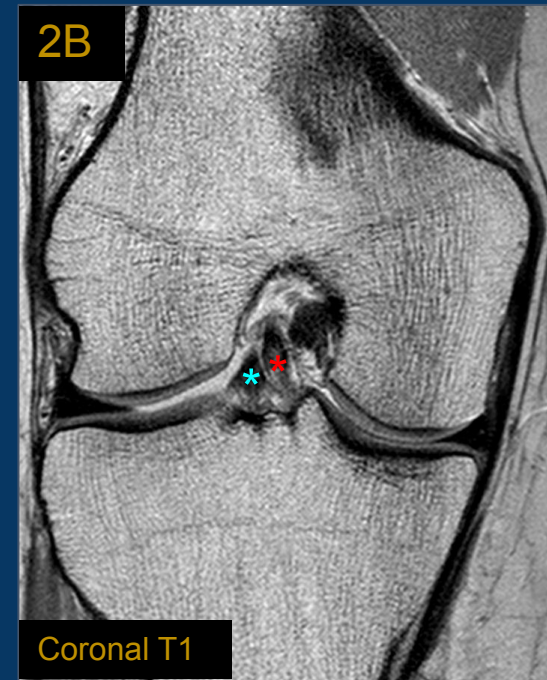
**Figure 2 (T1):** Coronal posterior (a) and anterior (b) images depict the two bundles of the ACL, the anteromedial and the posterolateral. Both originate from the inner aspect of the lateral femoral condyle and insert into the tibial eminence.

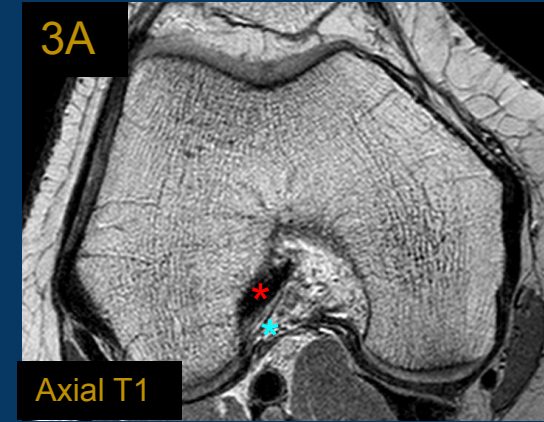
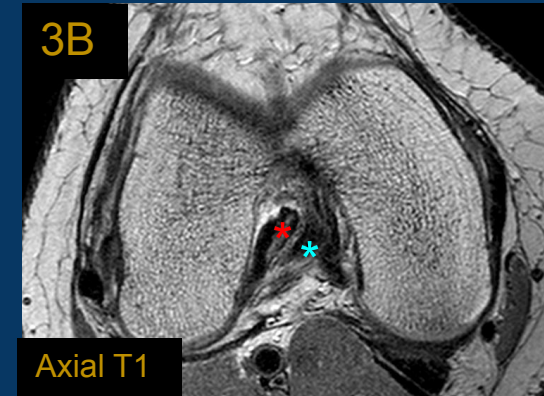
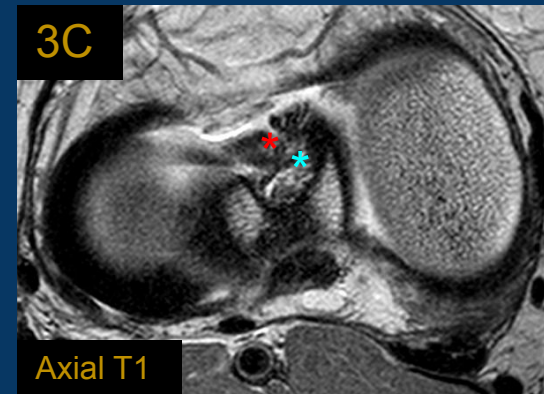
**Figure 3 (T1):** Axial images, progressing from superior to inferior planes (a-c), depict the trajectory of the ACL. The ligament runs from a superior to inferior direction, posterior to anterior, and from lateral to medial.

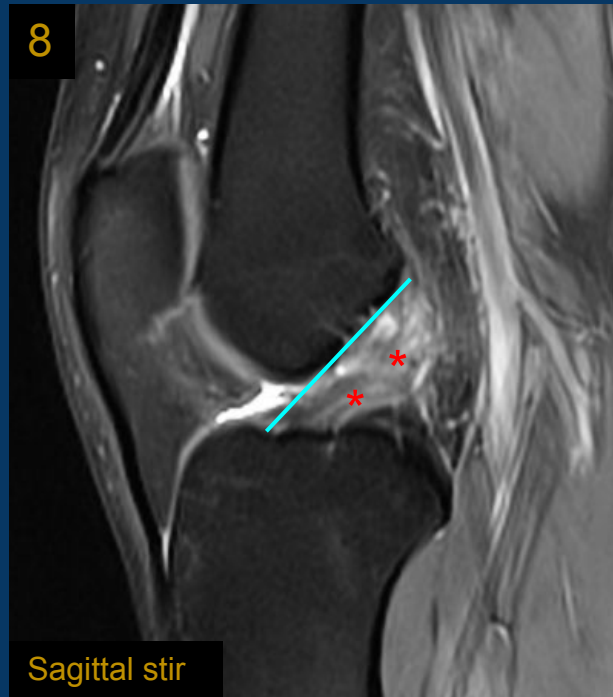
Sagittal stir

**Figure 8 (T1):** In sagittal imaging, a complete ACL rupture is evident, characterized by increased thickness and the absence of the typical fibrillar pattern (**red asterisks**). This high-grade lesion leads to a loss of tension within the ligament, resulting in a more horizontal trajectory. To objectively assess this, a line is drawn along the roof of the intercondylar notch of the femur, known as the Blumensaat line (**blue line**). The ACL should ideally be parallel to this line. However, in Figure 8, the ACL appears to be horizontally aligned in relation to the Blumensaat line.

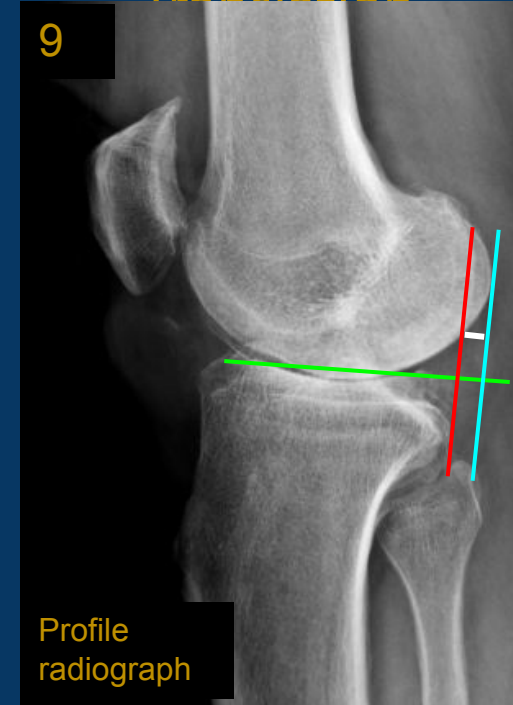
Profile radiograph

**Figure 9 (radiograph):** In a profile view of the knee, anterior tibial translation is evident, suggesting an ACL lesion, as the ACL is the primary structure responsible for resisting such movement. To assess this, a line was drawn tangent to the posterior contour of the medial tibial condyle (**red line**) and perpendicular to the medial tibial plateau (**green line**). The distance between this line and the posterior edge of the medial femoral condyle (**blue line**) should be less than 7.0 mm (**white line**).

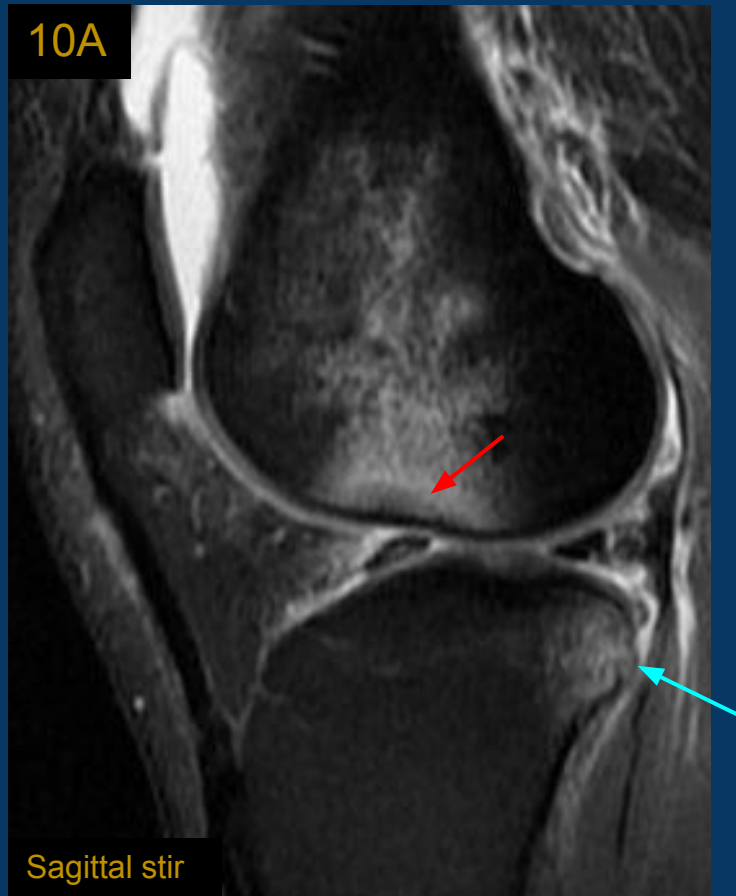
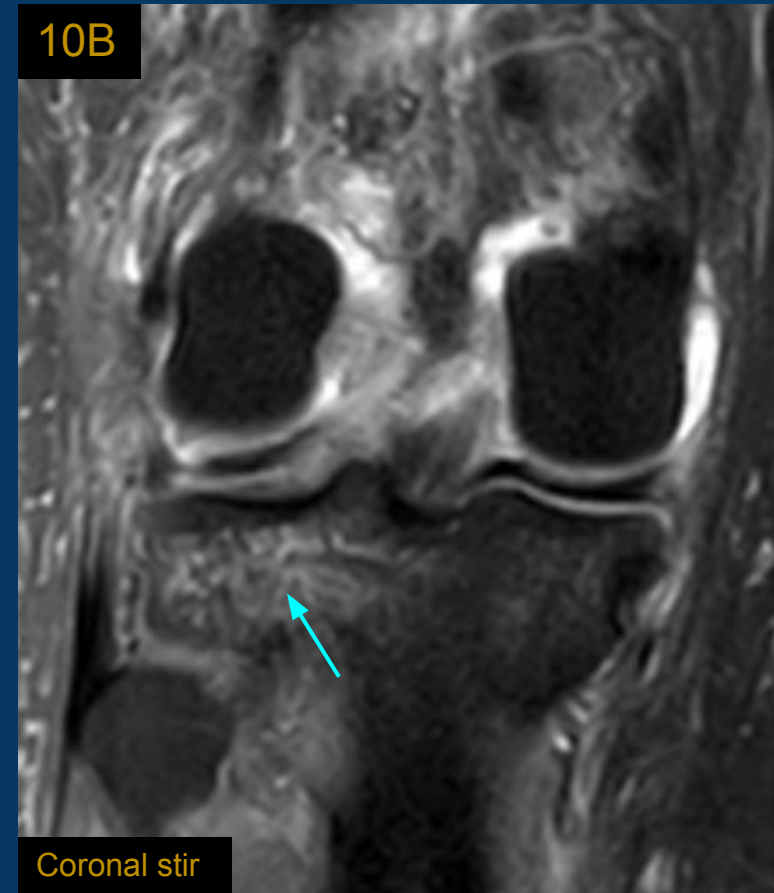
**Figure 10 (Stir):** Lateral sagittal (A) and posterior coronal (B) images of the knee display a pivot shift lesion in a patient who suffered complete thorn of the ACL (not shown). The pivot shift lesion is characterized by subchondral bone bruises and impaction on the central/anterior portion of the lateral femoral condyle (red arrow) and on the posterior part of the lateral tibial plateau (blue arrows). The trauma mechanism of the ACL injury typically involves a combination of valgus stress on the knee, anterior tibial translation, and external rotation of the tibia relative to the femur. The anterior tibial translation results in an impact between the central/anterior femoral condyle and the posterior tibial plateau. Concurrently, the valgus stress leads to a reduction in the lateral femorotibial compartment during the event, explaining why this is the side that gets affected.

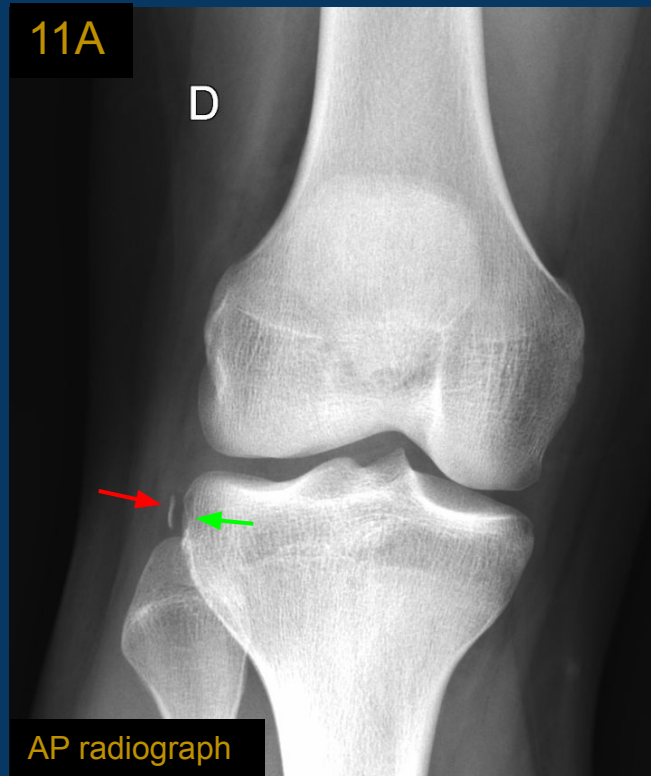
**Figure 11A (radiograph):** Anteroposterior view of the knee shows a bone fragment (**red arrows**) adjacent to the lateral contour of the tibial plateau (**green arrows**), consistent with an avulsion fracture of the distal insertion of the anterolateral ligament, known as a Segond fracture. This type of injury is associated with concomitant ACL lesion in more than 95% of cases (not shown in the figure).

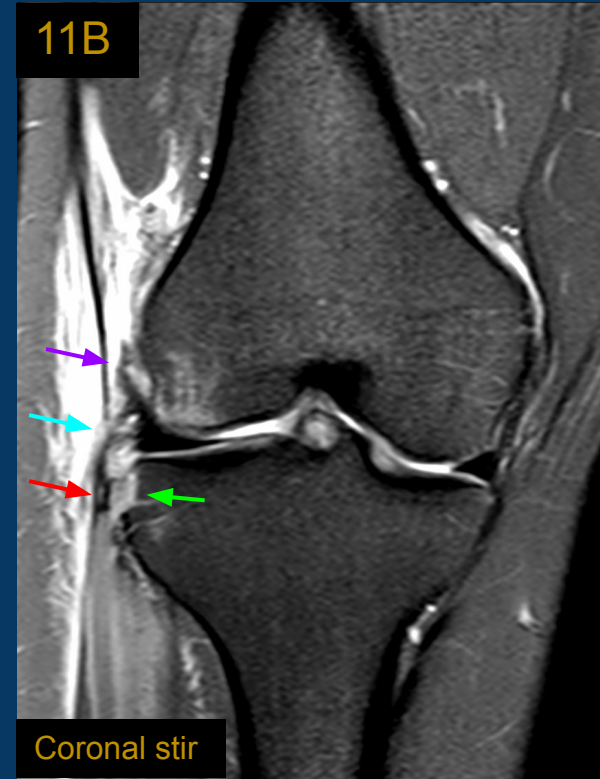
**Figure 11B (Stir):** Coronal image of the same patient depicts the anterolateral ligament with its menisofemoral component (**blue arrow**) and meniscotibial component (**purple arrow**). Both components appear thickened, irregular, and demonstrate elevated signal, suggestive of a sprain or partial lesion. Observe the bone fragment (**red arrows**) attached to the distal end of the meniscotibial component. This fragment was avulsed from the anterolateral contour of the tibial plateau (**green arrows**) and corresponds to the Segond fracture.

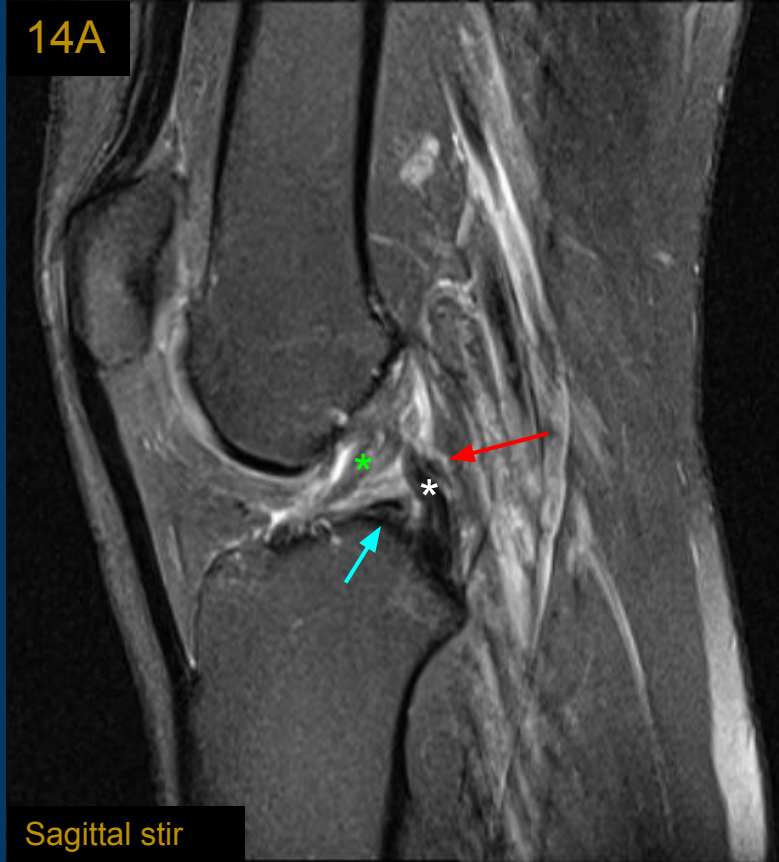
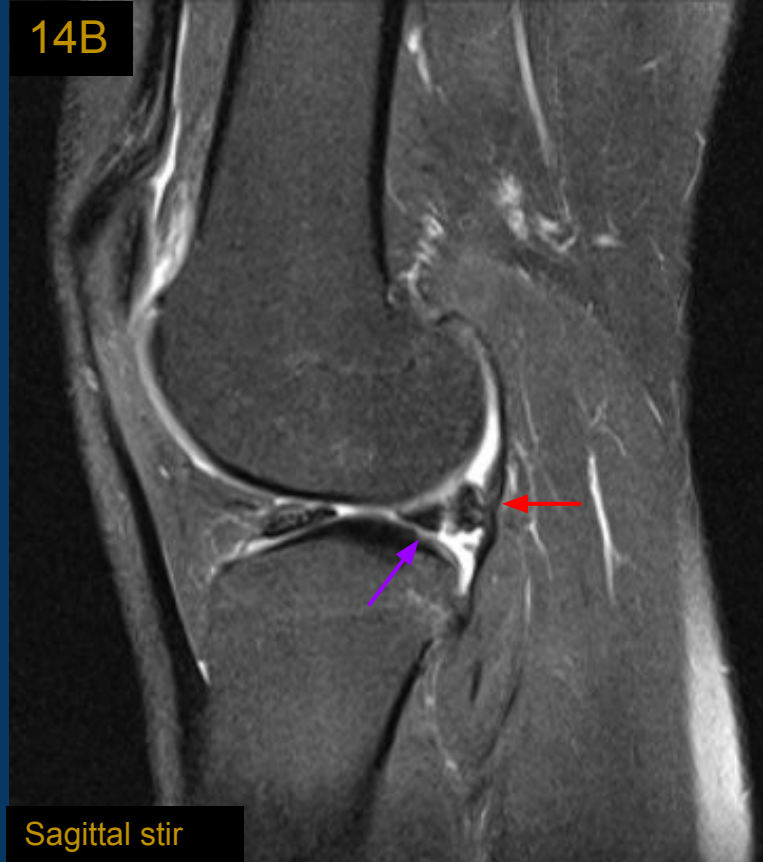
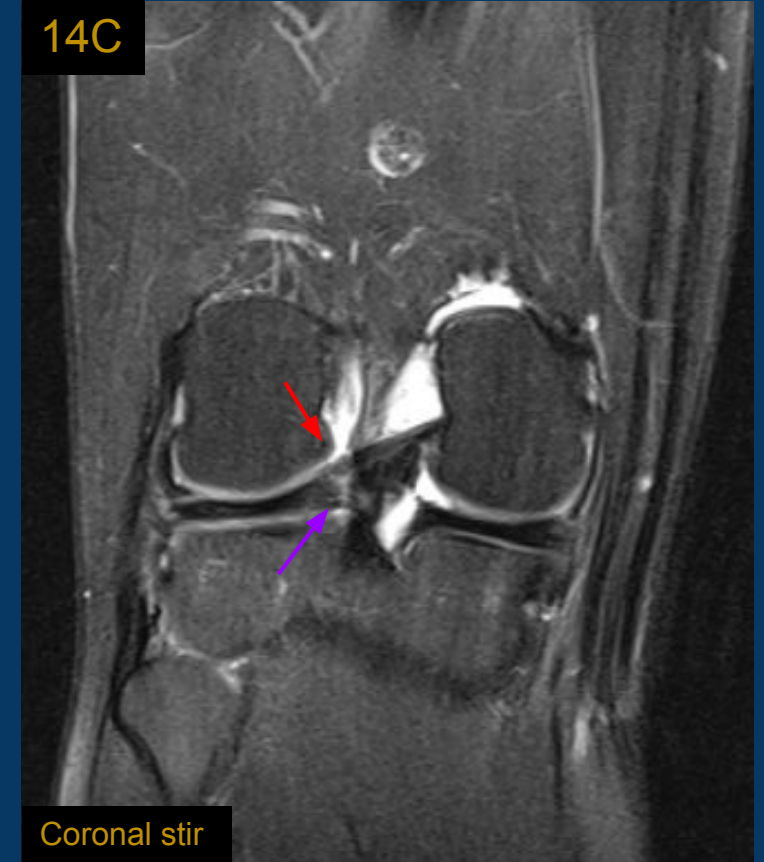
**Figure 14 (Stir):** Lateral sagittal (A,B) and posterior coronal (C) images of a patient's knee reveal a complete ACL lesion associated with a 'zip' lesion of the lateral meniscus. This type of injury involves a tear in the periphery of the posterior horn of the lateral meniscus, precisely at the site of the Wrisberg ligament insertion. In **figure 14A**, observe the torn ACL (**green asterisk**), the posterior root of the lateral meniscus (**blue arrow**), and the Wrisberg ligament (**red arrows**) passing posteriorly to the posterior cruciate ligament (**white asterisk**). **Figures 14B and 14C** show the posterior horn of the lateral meniscus (**purple arrow**) and the distal insertion of the Wrisberg ligament, revealing a noticeably widened gap between them. It can sometimes be challenging to distinguish a 'zip' lesion from the regular space between these two structures. Objectively, we might consider it a lesion if such separation stretches more than 1,4 cm from the lateral margin of the posterior cruciate ligament..
